# House Detectives, Inc.

## Property Inspection Report

1111 Sample Drive, Whitefish, MT 59937  
Inspection prepared for: Sample Report  
Date of Inspection: 10/7/2014 Time: 9:00 am  
Age of Home: built in 2003 Size: 4752 sf  
Weather: sunny, 47 degrees F, no rain in last 24 hours

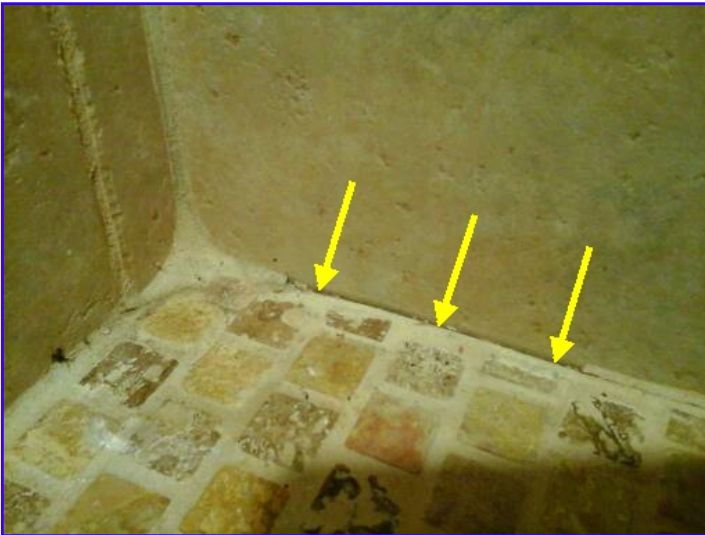
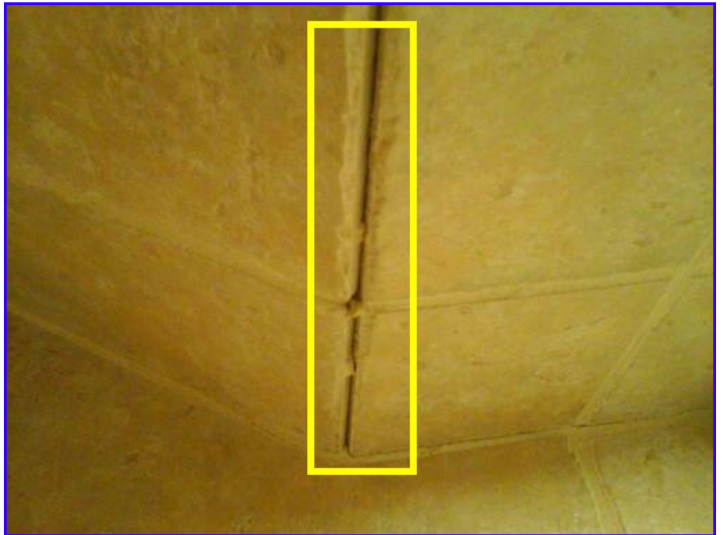
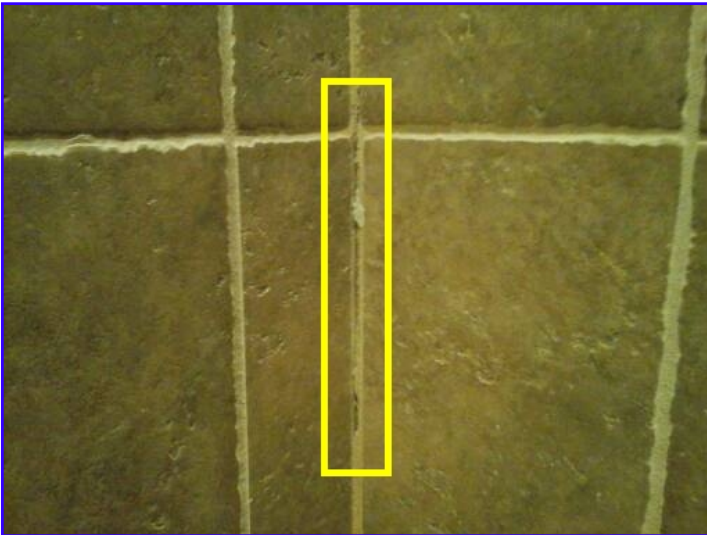
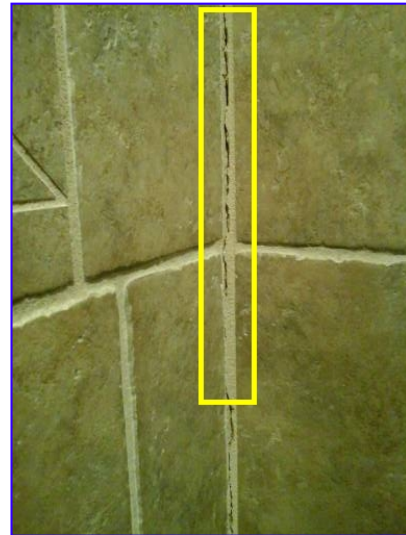
- Monitor all areas of tiled showers for openings in the grout where water may enter. Keep these areas sealed to avoid water damage behind the tile.

Keep all grout sealed.

Seal or re-grout where required.

- Ceramic tile is noted on the shower walls.
- *Suggest all tile edges and tub/shower walls be caulked and sealed to prevent moisture penetration. All missing/damaged grouting should be replaced. Failure to keep walls sealed can cause deterioration and extensive moisture damage to the interior walls and surrounding sub-flooring. This damage is not always visible or accessible to the inspector at the time of inspection.*

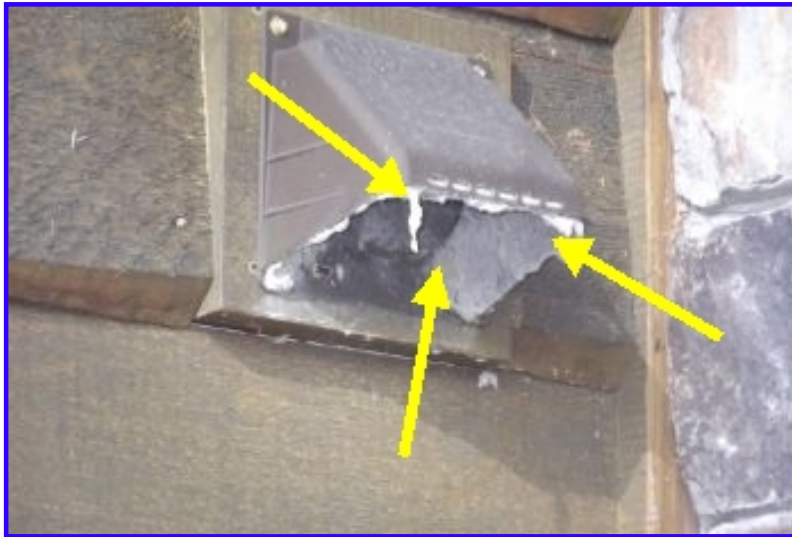
- Could not fully inspect the dryer vent, as it is obscured by drywall.

Visible lint inside of dryer vent cover indicates the need to clean the vent pipe.

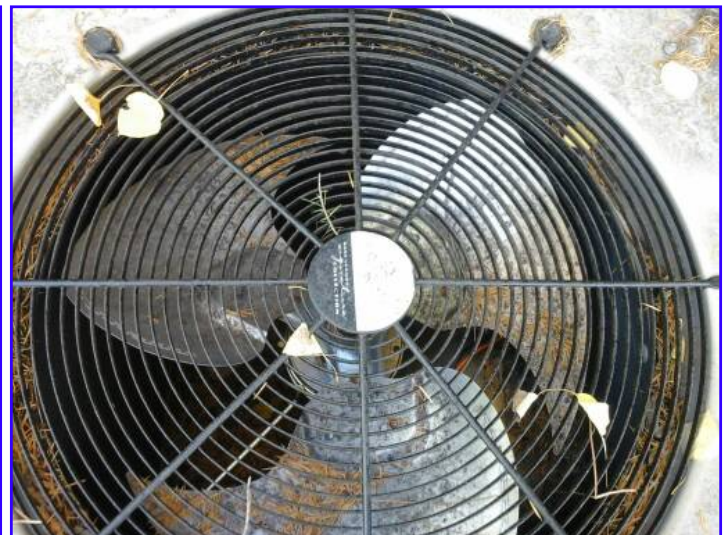
- The typical temperature differential split between supply and return air in an air conditioner of this type is 15 - 20 degrees F. This system responded and achieved an acceptable differential temperature of 16 degrees F.
- Annual HVAC service contract is recommended.
- *The exterior condensor is dirty and needs to be cleaned.*

Clean pine needles and leaves from compressor housing.

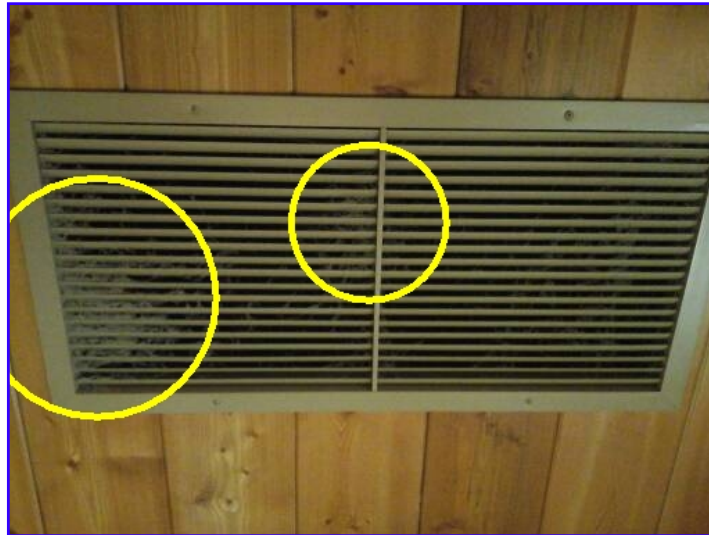
- The return air supply system appears to be functional, although the vents need to be cleaned.

Clean return air registers.

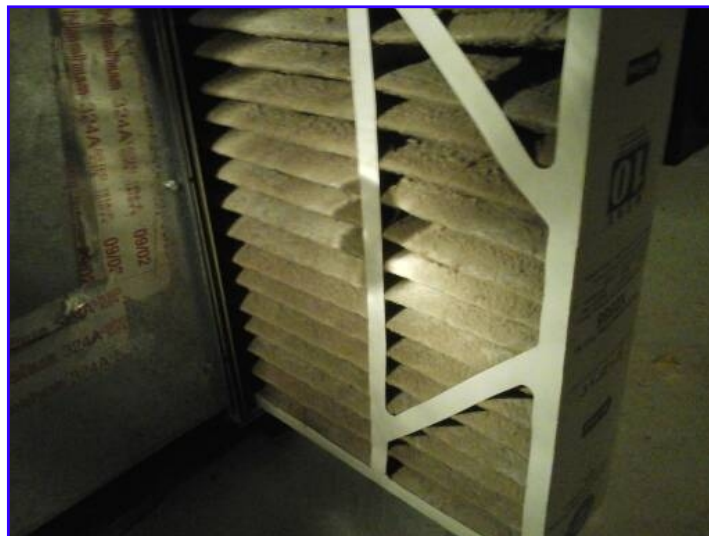
Replace dirty filter. 20x25x5, MERV 10 or better.

- **MAINTENANCE:** The air filter(s) should be inspected at least monthly and cleaned or replaced as required. There are two types of filters commonly used: (1) Washable filters, (constructed of aluminum mesh, foam, or reinforced fibers) these may be cleaned by soaking in mild detergent and rinsing with water. Or (2) Fiberglass disposable filters that must be **REPLACED** before they become clogged. Remember that dirty filters are the most common cause of inadequate heating or cooling performance.

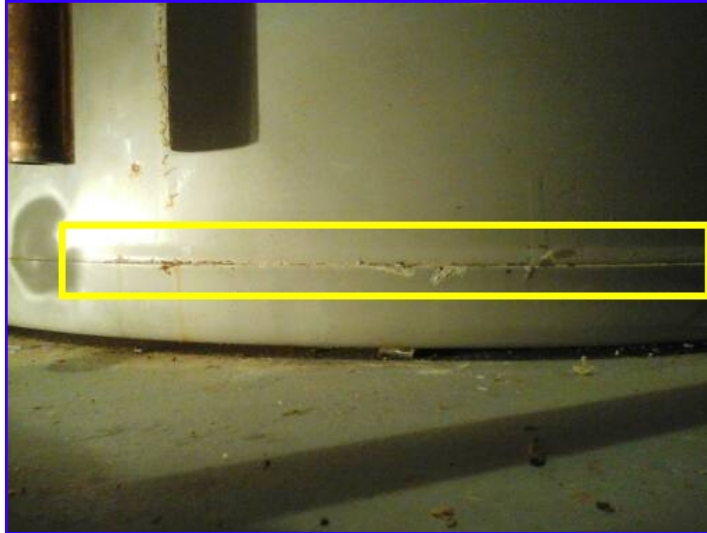
- The water heater base is showing signs of slight corrosion and may be approaching the end of its useful life.

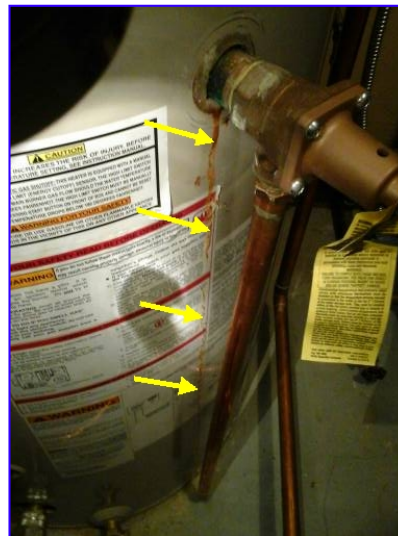
- A pressure & temperature relief valve & extension is present. There appears to be a small dry trail of rusty water from the pipe exiting the tank where the TPRV connects. This was not leaking at the time of inspection, however it maybe an indication of the condition of the inside of the tank.

Rusty drip line out of TPRV opening, dry at time of inspection.

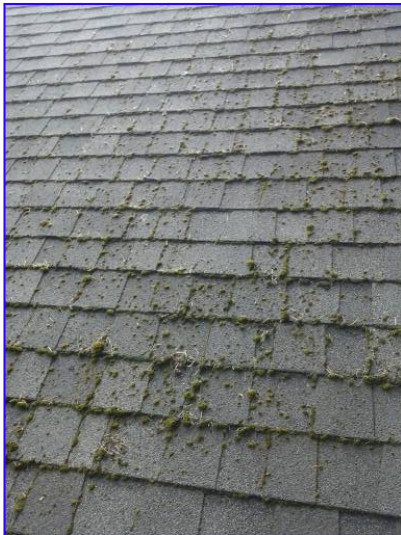
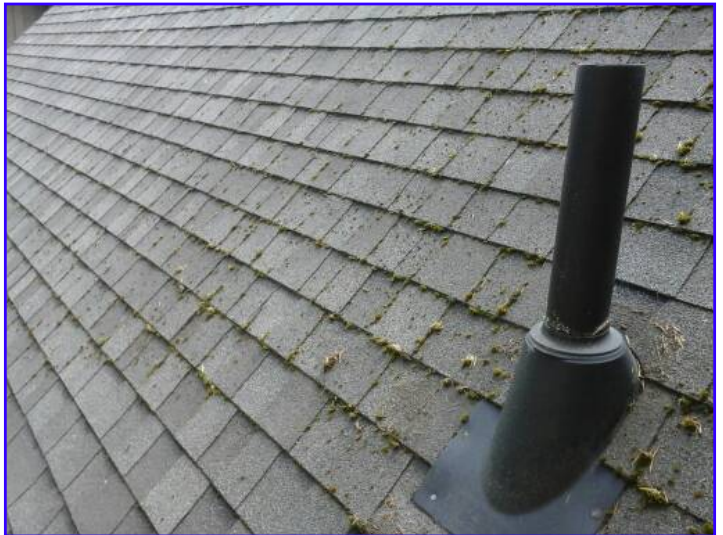
**• Moss on roof. This can lead to the premature failure of the roof and subsequent leaks. Recommend treating moss during its growing season (wet months) with a moss killer. For information on various moss treatment products and their pros and cons, visit <http://bryophytes.science.oregonstate.edu/page24.htm>.**

Moss on North side of roof.

More moss on North side of roof.

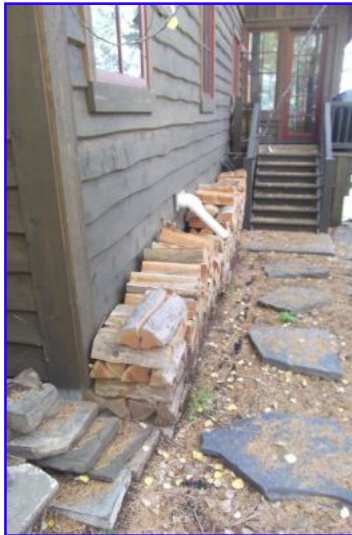
**• Firewood storage is too close to the home and may lead to insect or rodent damage. Move the firewood away from the house.**

Move firewood away from siding.

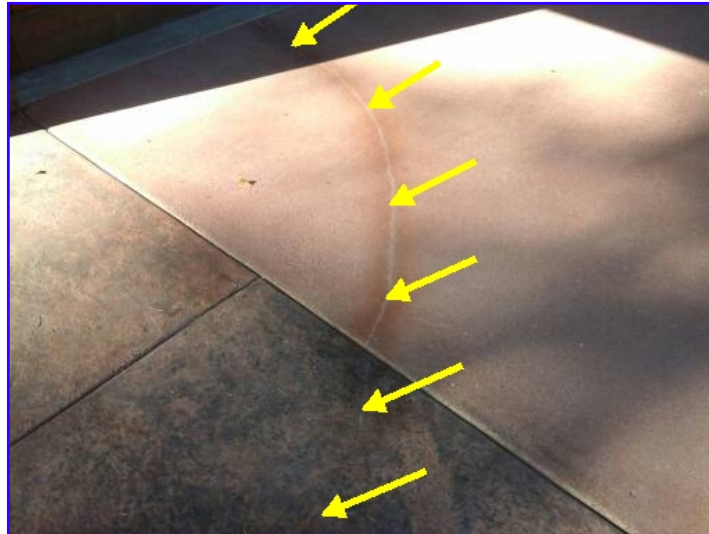
• Concrete driveway appears new. Highly recommend sealing within one year to extend life and maintain appearance. There is one hairline crack in front of the South garage door that needs to be monitored for continual expansion.

There is one hairline crack in front of the South garage door that needs to be monitored for continual expansion.

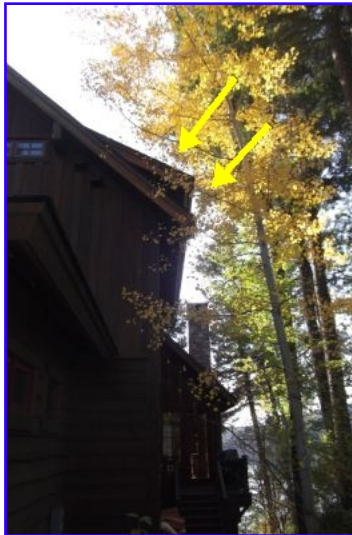
• Tree limbs within 10 feet of roof should be trimmed away to provide air and sunlight to roof, while minimizing debris & dampness.

Keep branches trimmed back off of house.

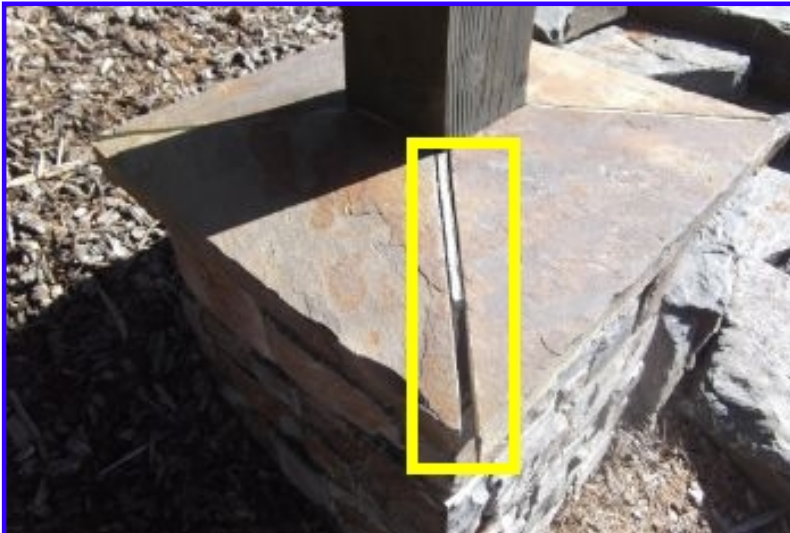
Cracked and missing grout around lower deck posts needs to be repaired.

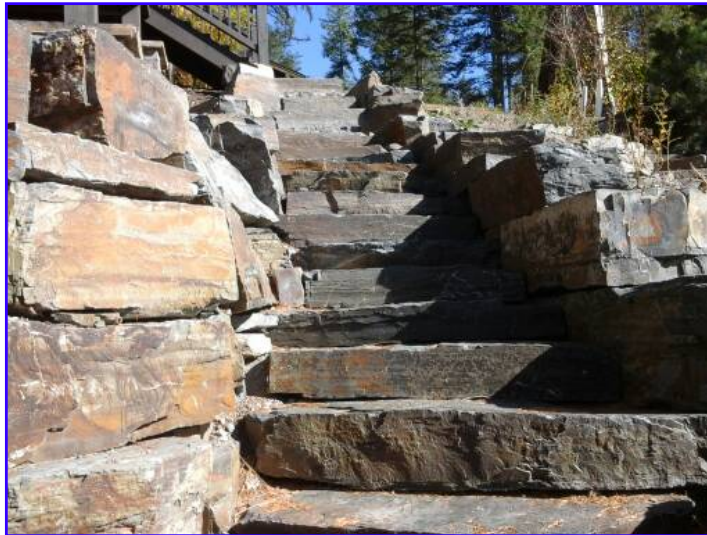
- There were no railings installed at the rock steps to the lake. This is a potential tripping hazard as the rocks are not symmetrical in height. Recommend installing protective railings. All other stairs and railings are in serviceable condition at the time of the inspection.

Uneven step heights, use caution.
