# House Detectives, Inc.

## Property Inspection Report

1111 Sample Drive, Whitefish, MT 59937  
Inspection prepared for: Sample Report  
Date of Inspection: 10/7/2014 Time: 9:00 am  
Age of Home: built in 2003 Size: 4752 sf  
Weather: sunny, 47 degrees F, no rain in last 24 hours

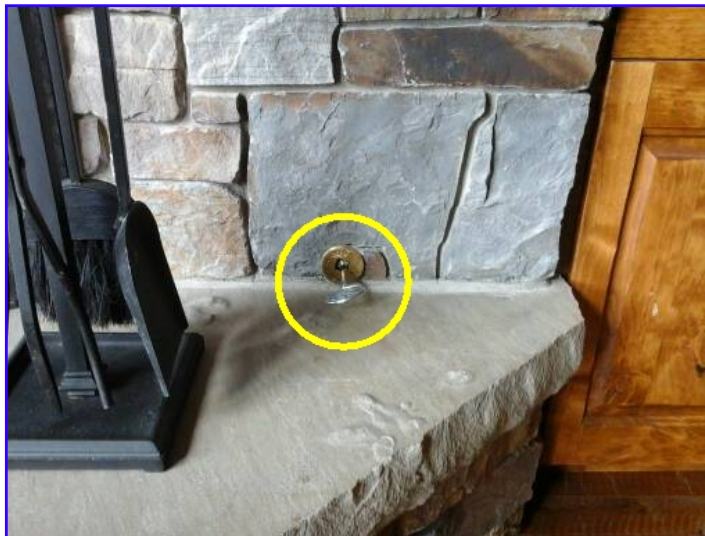
- Damper was opened and closed several times.
- The wood burning fireplace has a gas log lighter. This should not be left constantly on like a gas fireplace, and the gas valve is noted to the right side of the fireplace, if facing the fireplace. It is for lighting wood logs only, and NOT TO BE USED WITH CERAMIC GAS LOGS.
- Have a fireplace professional evaluate and repair any issues found before attempting to use fireplace.

Gas log starter valve for fireplace. Turn clockwise to turn off.

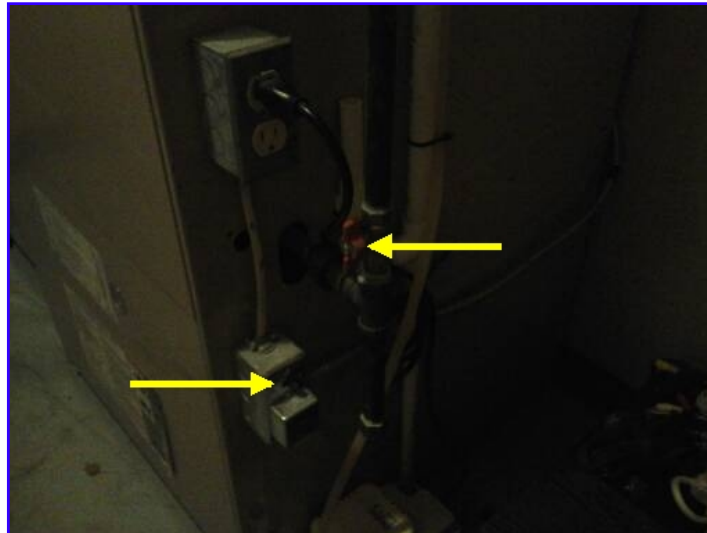
- Gas shut off valves were present and functional.

Gas shut off valve at top arrow, main furnace electric cut off switch at bottom arrow.

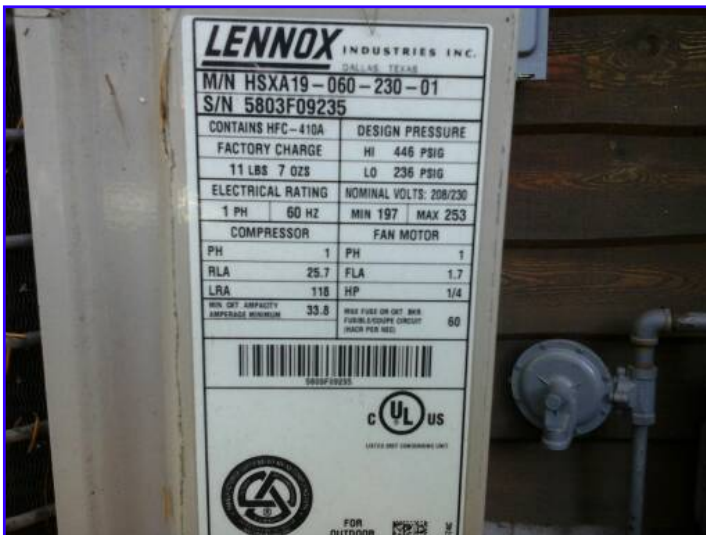
- The typical temperature differential split between supply and return air in an air conditioner of this type is 15 - 20 degrees F. This system responded and achieved an acceptable differential temperature of 16 degrees F.
- Annual HVAC service contract is recommended.
- *The exterior condensor is dirty and needs to be cleaned.*

5 Ton capacity compressor.

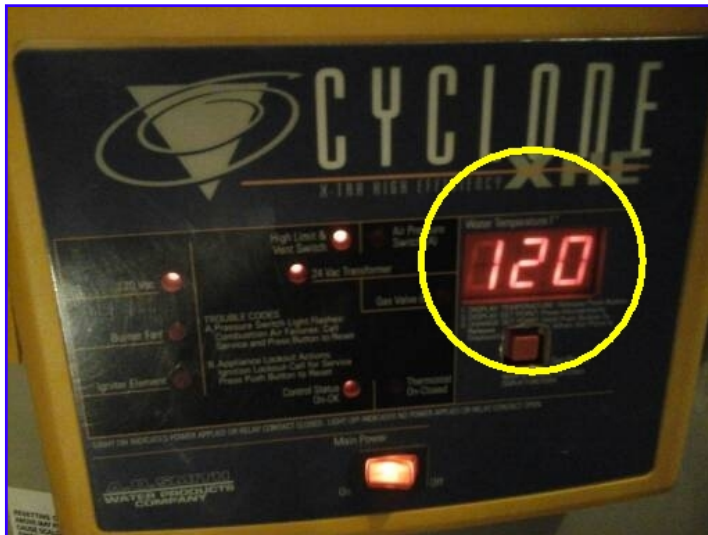
- Water temperature observed to be 120 degree F. This is satisfactory. Recommended temp should be set at 118-122 degrees F to prevent scalding, extend water heater life, and improve energy efficiency and conservation.

Hot water temperature.

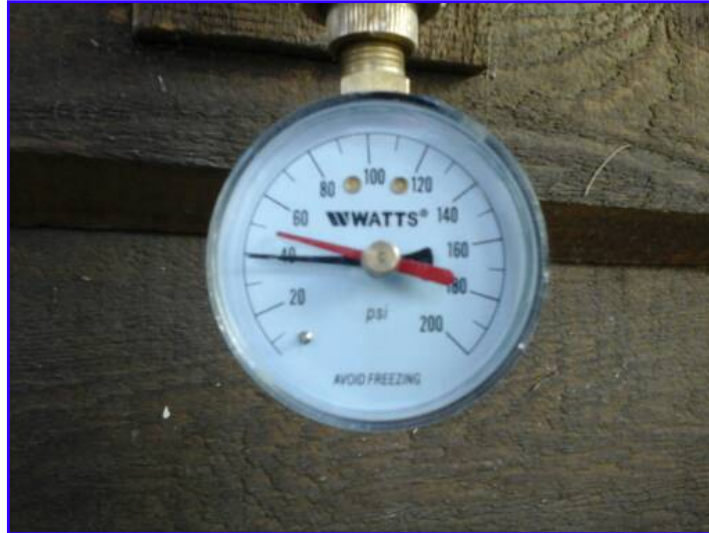
- 40 - 50 psi.

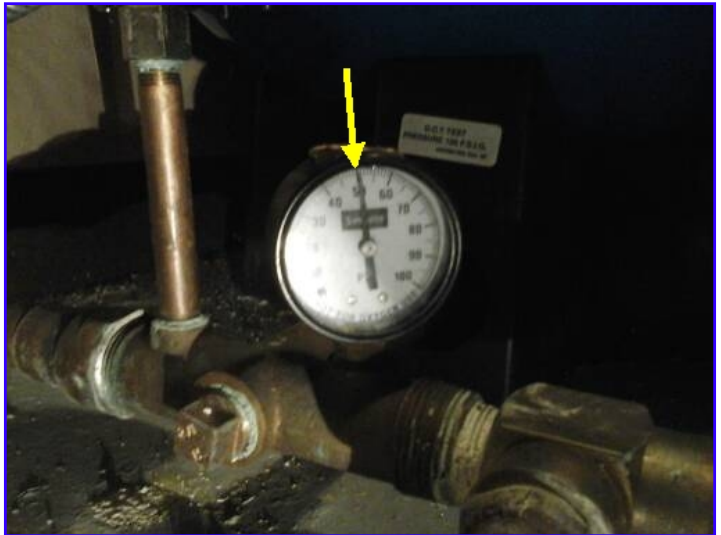
Pressure switch set to 50 psi.

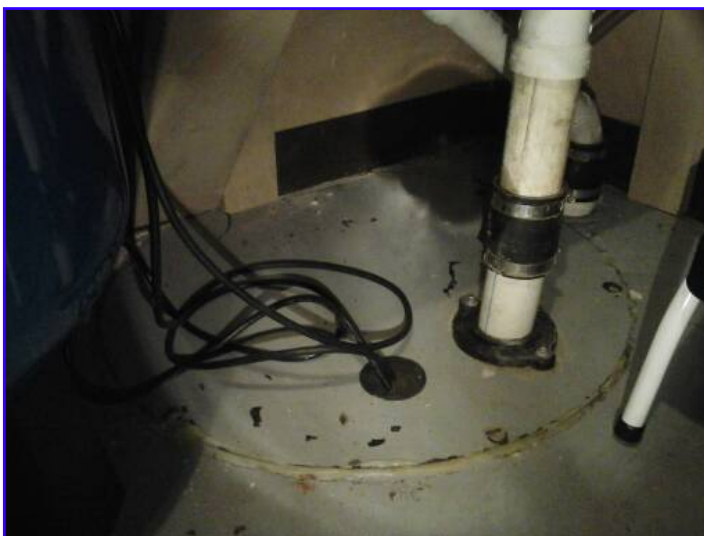
Sewage grinder/pump in basement mechanical room.

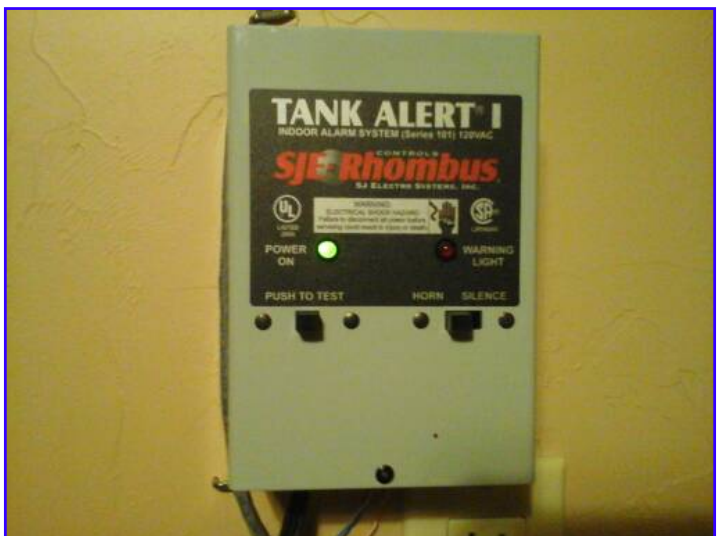
Septic alarm in mechanical room.
